HTT Flooring - Laminate Flooring MTF Range - Wet Sliptest SN170723-1

Slip Resistance Classification of New Pedestrian Surfaces - AS4586:2013

This Test Report Is In Accordance with Appendix A	Wet Pendulum Test
Date Tested:	17 Jul 2023
Test Report Number:	SN170723-1
Client Name & Billing Address:	HTT Flooring Pty Ltd - Unit 2, 8 Gunya Street Regents Park NSW 2143
Project Name or Test Location:	HTT Flooring Showroom - 1b/42-44 Birnie Ave Lidcombe NSW 2141
Surface Tested :	Laminate Flooring MTF Range - 5 Colours
<i>Samples and Test Information Supplied by Client</i>	
Wet Pendulum Test carried out using :	Slider 96 (4S) Rubber slider
Testing Officer / Approved Signatory:	Shenea Neill
Pendulum in use - Calibration Date :	#1133 - Munro-Stanley Portable Skid Tester (C : 14.10.21)
Signature of Approved Signatory :

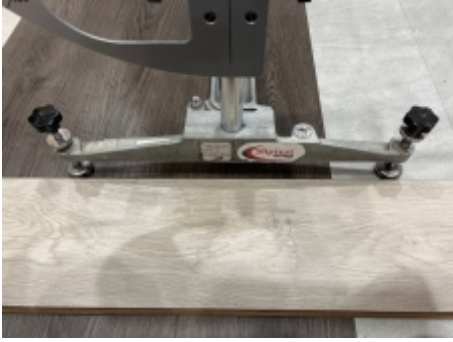
Sample No.	Swing 1	Swing 2	Swing 3	Swing 4	Swing 5	Mean BPN of last 3 swings :	SCV :	Surface Picture
Driftwood	30	30	30	30	30	30	N/A

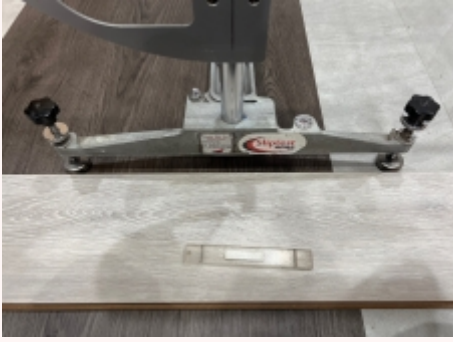
Washed Oak	26	26	25	25	25	25	N/A

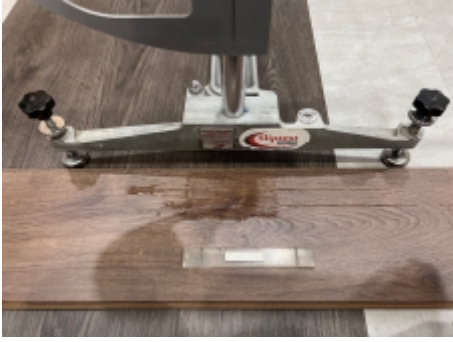
Brown Vintage Oak	30	28	27	27	27	27	N/A
