HTT Flooring - Hydrocore Timber Flooring 2 of 2 Sample - Wet Sliptest SN240424-17

Slip Resistance Classification of New Pedestrian Surfaces - AS4586:2013

This Test Report Is In Accordance with Appendix A	Wet Pendulum Test
Date Tested:	24 Apr 2024
Test Report Number:	SN240424-17
Client Name & Billing Address:	HTT Flooring Pty Ltd - Unit 2, 8 Gunya Street Regents Park NSW 2143
Project Name or Test Location:	Sliptest Australia NSW Headquarters - 5 Joynton Ave, Zetland NSW 2017
Surface Tested :	Hydrocore Timber Flooring 2 of 2 Sample
Wet Pendulum Test carried out using :	Slider 96 (4S) Rubber slider
Any Variations to Standards	N/A
Testing Officer / Approved Signatory:	Shenea Neill
Pendulum in use - Calibration Date :	#1133 - Munro-Stanley Portable Skid Tester - (C: 13.10.23 - EN 13036-4)

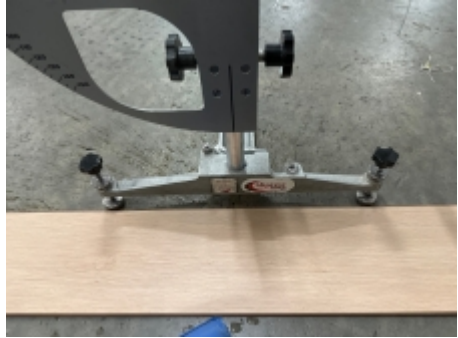
Sample No.	Swing 1	Swing 2	Swing 3	Swing 4	Swing 5	Mean BPN	SCV :	Surface Picture
Brandy	36	36	36	35	35	35	N/A

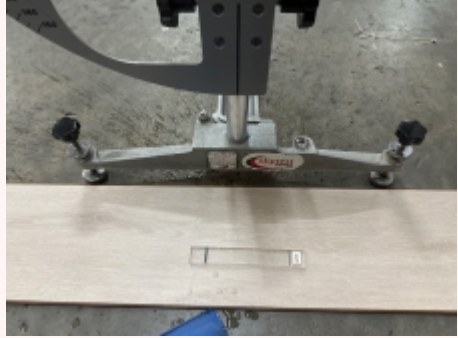
Golden Fog	25	25	24	24	24	24	N/A

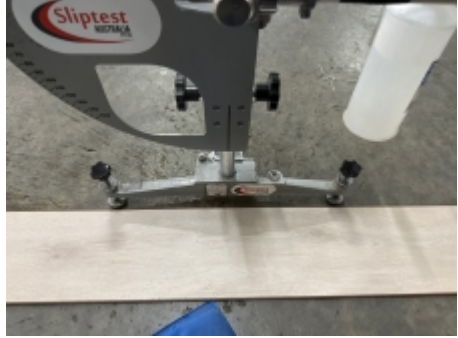
Golden Fog	26	26	25	24	24	24	N/A
