**HTT Flooring - Aquaglow Range Samples 1 of 2 - Wet Sliptest SN161123-9** 17 Nov 2023

**Slip Resistance Classification of New Pedestrian Surfaces - AS4586:2013**

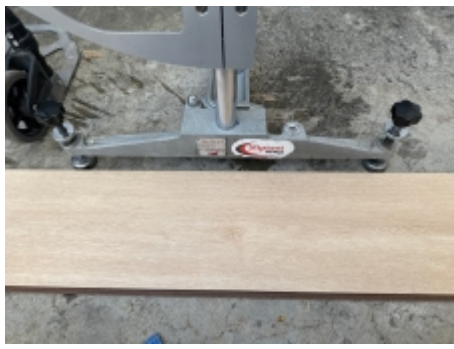
Sample No.	Swing 1	Swing 2	Swing 3	Swing 4	Swing 5	Mean BPN of last 3 swings :	SCV :	Surface Picture
WF01 - LA Oak	31	31	31	31	31	31	N/A

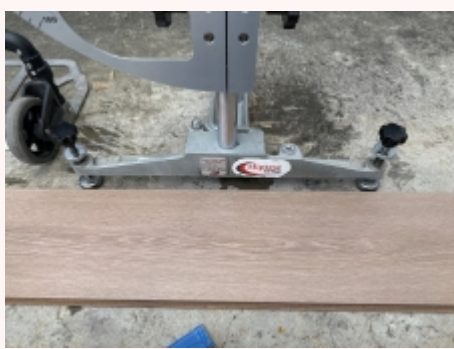
WF04 - Caramel Oak	30	28	27	26	26	26	N/A

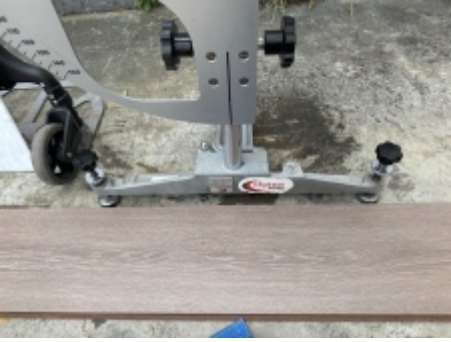
Sample No.	Swing 1	Swing 2	Swing 3	Swing 4	Swing 5	Mean BPN of last 3 swings :	SCV :	Surface Picture
WF03 - London Oak	30	28	27	26	26	26	N/A

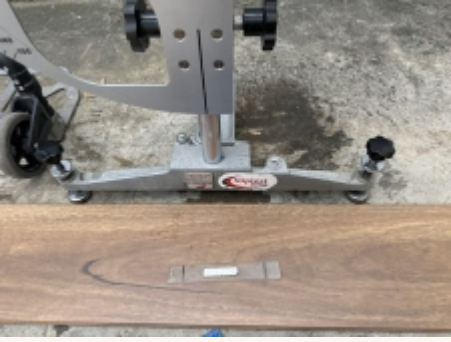
WF08 - Spotted Gum	28	28	26	25	25	25	N/A

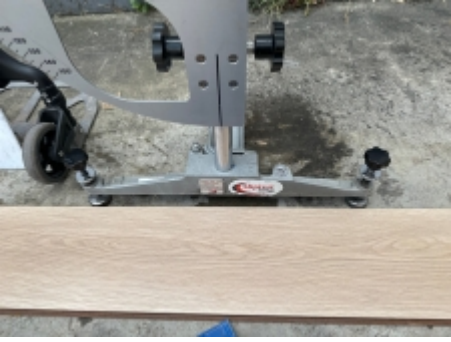
WF05 - New York Oak	25	25	25	25	25	25	N/A
