**HTT Flooring - Duro Hybris 5+2mm Range - Wet Sliptest SN170723-3**

**Slip Resistance Classification of New Pedestrian Surfaces - AS4586:2013**

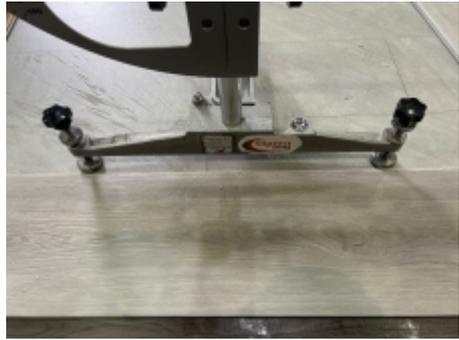
Sample No.	Swing 1	Swing 2	Swing 3	Swing 4	Swing 5	Mean BPN of last 3 swings :	SCV :	Surface Picture
Mediterranean	55	55	54	54	54	54	N/A

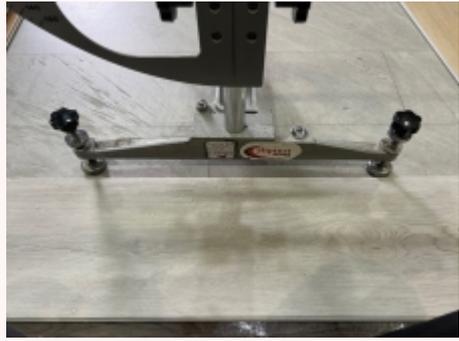
Magnolia	54	53	52	52	52	52	N/A

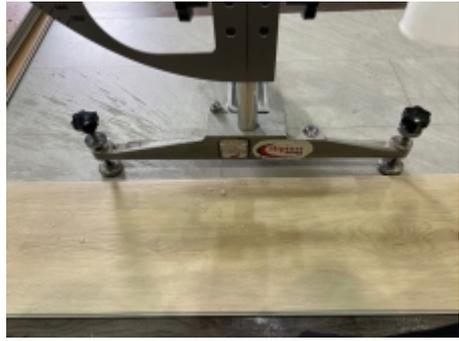
Japandi	50	49	48	48	48	48	N/A
